Historical Land Use Investigation

1905A South 6th Street Milwaukee, Wisconsin

File: 468-01

April 4, 2019

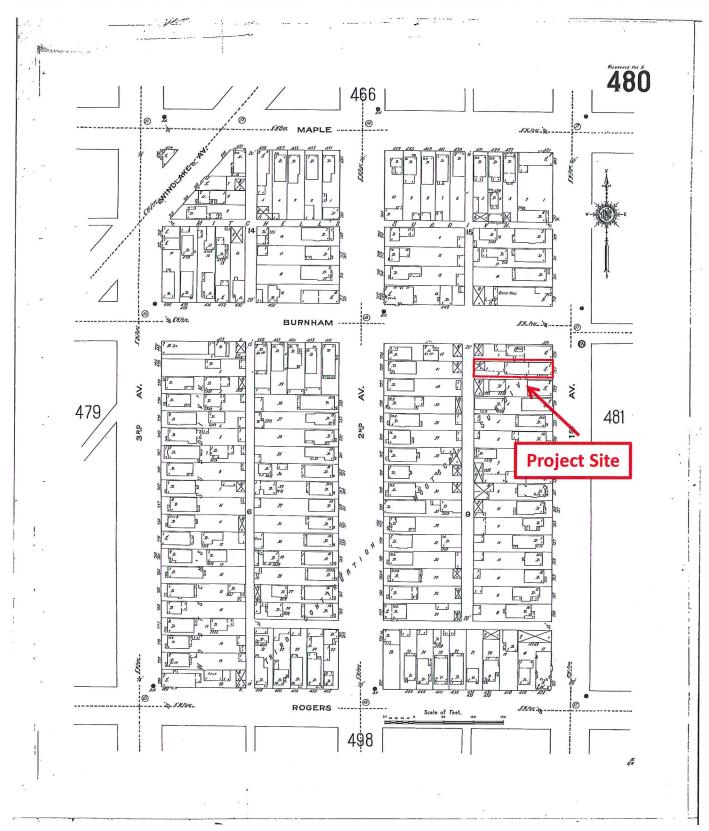
1937 Sanborn Fire Insurance Map

- 1. A 1910 (with updates through 1937) Sanborn Fire Insurance Map shows the project site as a two story store with a stable on the western part of the lot line. The rest of the neighborhood is a steady mix of commercial and residential properties. The area surrounding the project site is very well built out, with almost no empty lots.

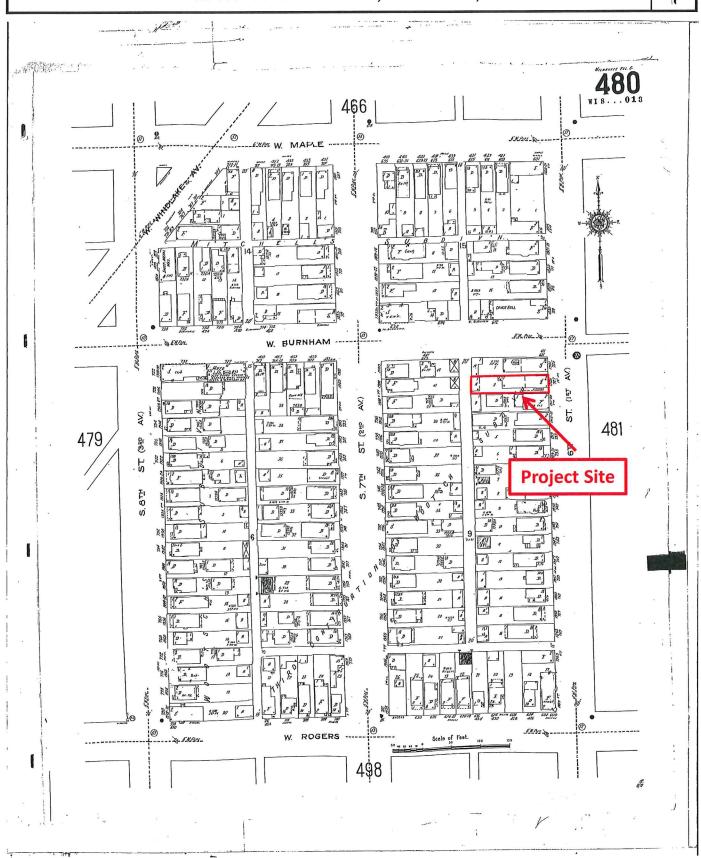
1951 Sanborn Fire Insurance Map

- 2. A 1910 (with updates through 1951) Sanborn Fire Insurance Map shows the project site similarly to what it was in the previous map. It is still a two story store. However, the stable from the previous map has been replaced with a garage. It appears many nearby properties have also replaced stables with more modernized garages. The neighborhood is still a steady mix of commercial and residential buildings.

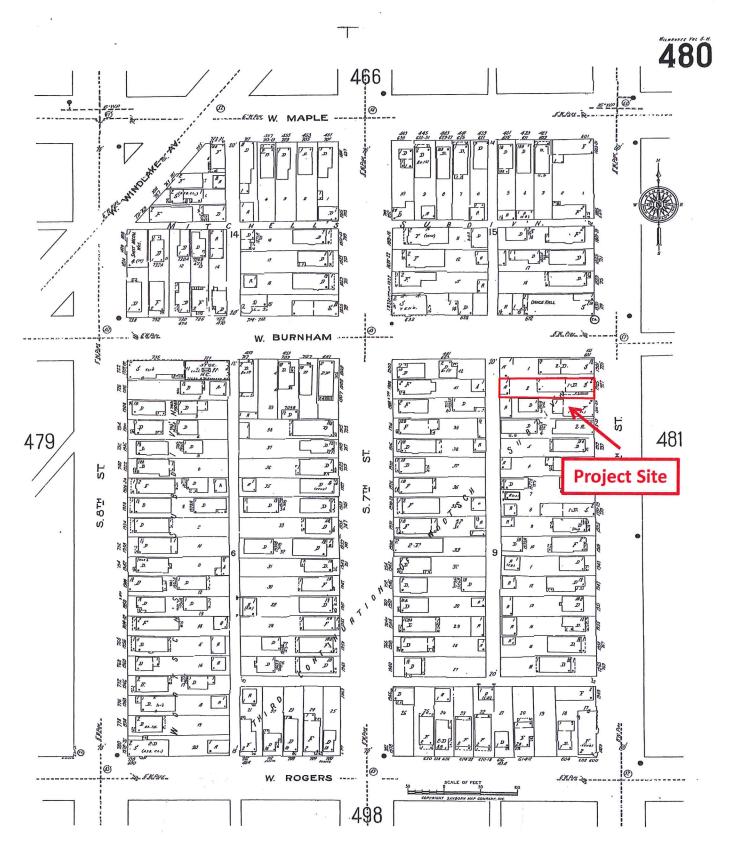
1969 Sanborn Fire Insurance Map

- 3. A 1910 (with updates through 1969) Sanborn Fire Insurance Map shows the project site as a two story store. However, it is also designated as a dwelling, along with neighboring properties. This most likely indicates that the property is mixed use, with commercial on one floor and living quarters on the other. The rest of the surrounding areas has remained unchanged, with a steady amount of flats and dwellings, with a few commercial properties as well.

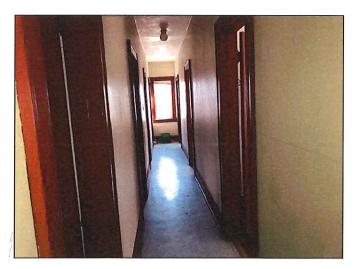
Corridor in upstairs residential area

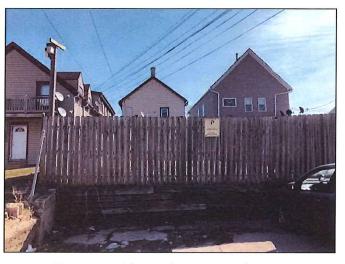
Parking area and fence of project site, facing east

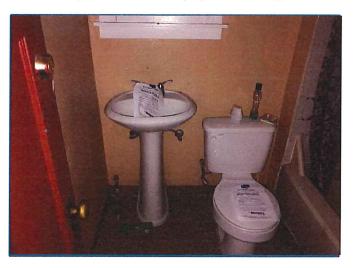
Bathroom on second floor residential area

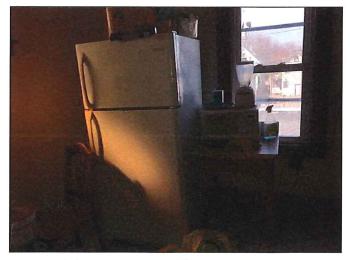
Kitchen area in second floor residential area
